2220 I'ON AVENUE
Review of Demolition, Alterations, and Addition
September 2018

DRB
A108

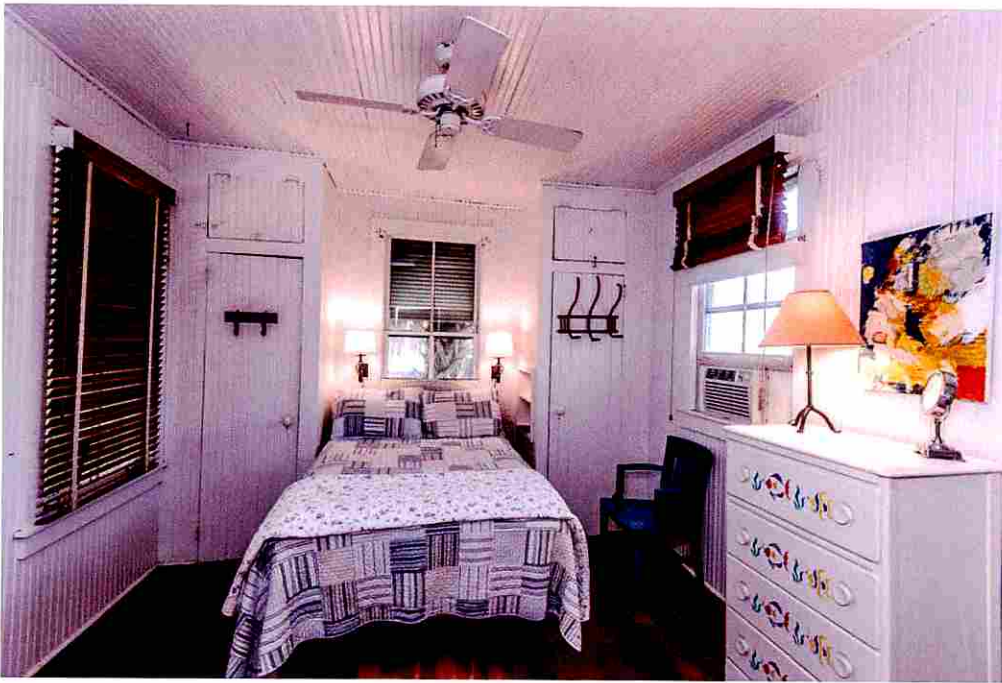
Figure 5. Original southern second floor bedroom with two closets shows the original simplistic wall and ceiling paneling and trim that still existing throughout the original structure along with the hard pine flooring, which no longer exists in the kitchen only.

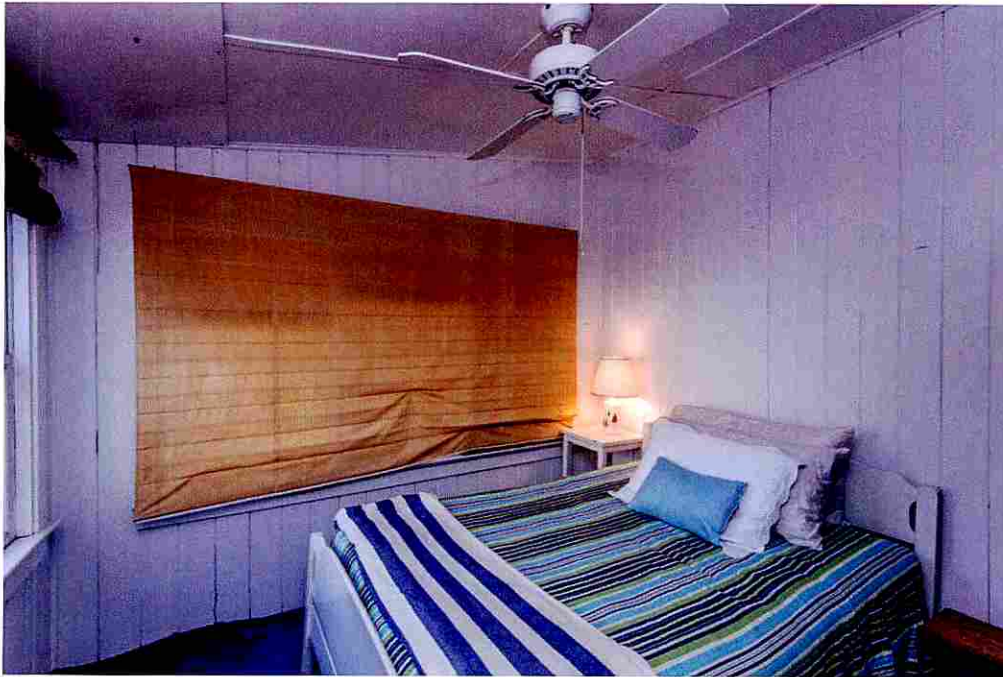
Figure 7. The above pictures shows the second floor fill south of the kitchen to create a second bedroom on the main level. No hardwoods are visible, paneling and windows do not match the existing original architectural fabric.

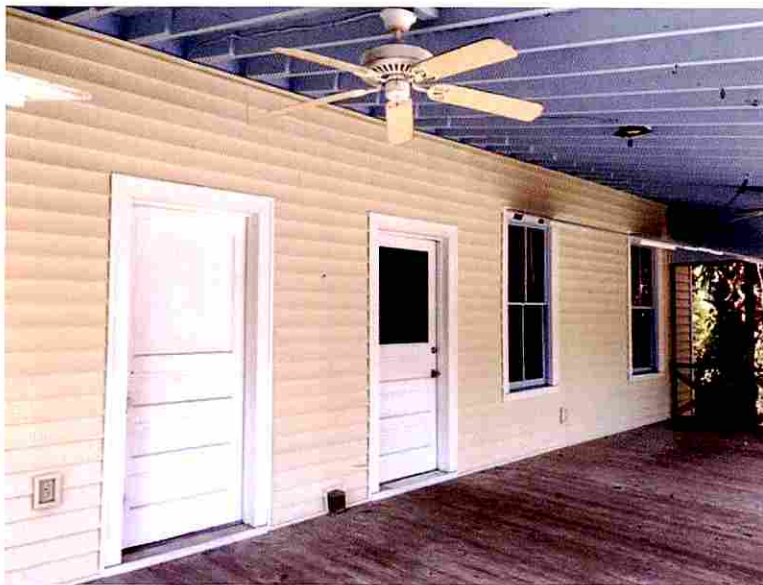
Figure 8. The photo above is of the original main level façade facing the street. The original doors and windows remain. Requesting windows to be reused rear addition with existing windows to be altered into narrow French doors that can be found on similar neighboring historic properties located at 2250 I'on and 2256 I'on.

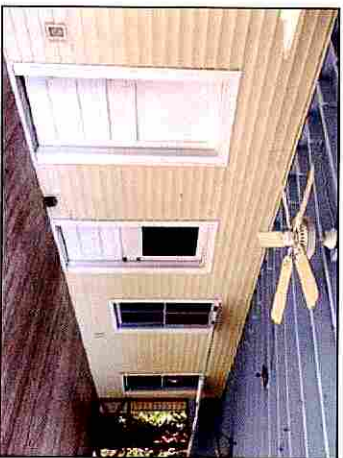
EXISTING FRONT PORCH CONDITIONS
LEFT DOOR TO BE RELOCATED TO SIDE GRILLING PORCH
WINDOWS TO BE REUSED AT REAR MASTER ADDITION

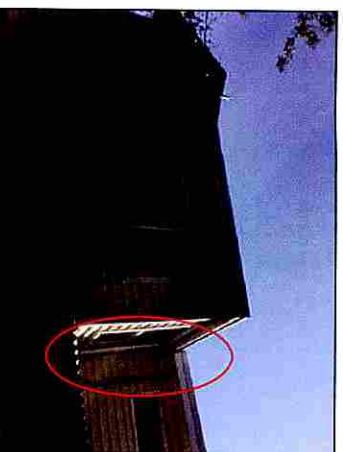
EXISTING REAR LATER SECOND ADDITION
WINDOWS TO BE REMOVED AND SIDING TO MATCH IN KIND
RIGHT WINDOW TO BE USED AS ADDITION ACCESS DOOR

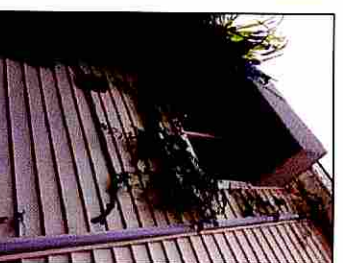
NON HISTORIC NORTH WINDOW
WINDOWS TO BE COME EXTERIOR
DOOR AT GRILLING PORCH

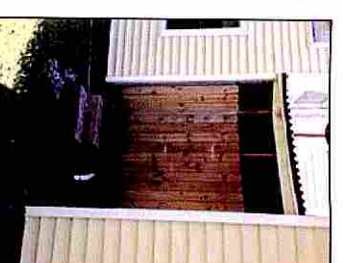
REAR SHOWER
REAR SHOWER TO BE ENCLOSED
TO EXISTING BATHROOM

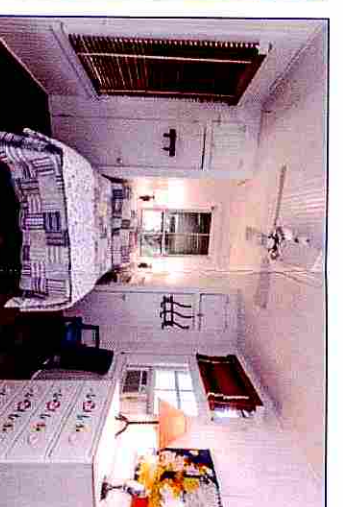
HISTORIC INTERIOR THROUGHOUT
PAINTED WOOD PANELING ON WALLS AND CEILINGS
HEART PINE FLOORING
MINIMALIST TRIM AND DETAILING TO REMAIN
